WoundPro®

Healing. Simplified.

Understanding and Resolving Blockage Alarms

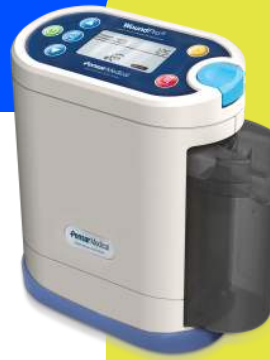
The WoundPro® is an advanced NPWT system renowned for its simplicity and effectiveness. It features the most reliable and powerful pump in the industry to promote accelerated wound healing and enhance patient outcomes.
